WISDOM & WOE FROM THE WORKSHOP

Hello and welcome to the first of a regular technical column for Sprint magazine - written by myself and Nathan Lloyd, from Lloyd Specialist Developments Ltd.

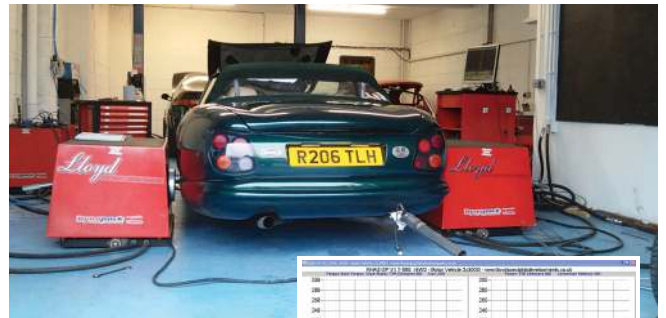
We recently had a TVR Car Club RO bring his car to us for a basic health check and a power run on our chassis dyno, only to find it down on power and noticeably misfiring at around 4000rpm. We removed the spark plug extenders and found 3 of them to be faulty. Replacing these intermittent faulty extenders gained 20bhp at the hubs. A quick tweak of the ignition timing on the dynamometer gained us a further 16bhp at the hubs, netting a very worthwhile and cheap power increase! It is worth noting that these micro-misfires will also increase fuel consumption and affect the general driveability of the car.

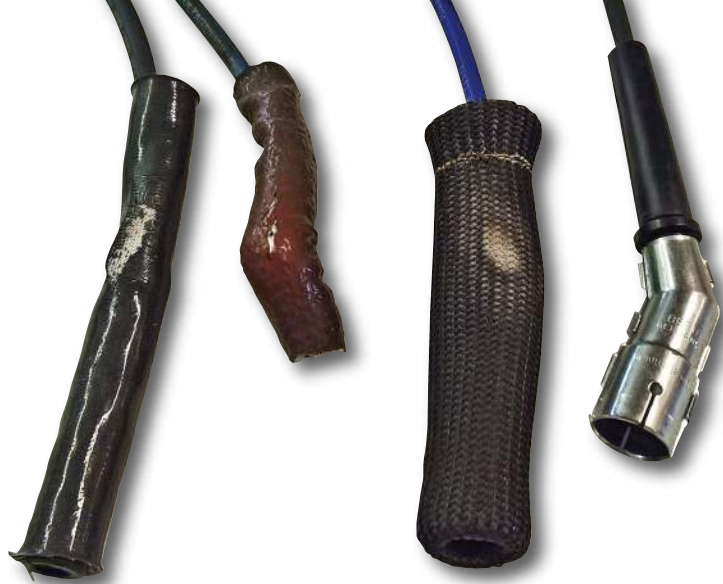
So can we not simply remove those pesky spark plug extenders? Well, it is possible to remove the extenders from cylinders 1, 2, 3 and 4 without noticeably reducing the life of the corresponding HT leads but this still leaves the last few extenders. One increasingly common method is to remove all of the extenders and fit high-temperature heat socks over the HT leads at the spark plugs. The only problem with this is that the heat-socks on the rear-most cylinders will usually then be in contact with the exhaust manifolds and not even the best heat socks are able to tolerate that for long! Even though the heat sock doesn't necessarily burn, it still conducts heat through to the HT lead.

Better quality HT leads with industrial oven cable insulation will improve the longevity slightly, but the problem will ultimately remain.
